Liquefaction damage by the 2011 off the Pacific coast of Tohoku Earthquake in Japan and land condition of damaged area detected by time serial geospatial information

Mamoru Koarai*, Takayuki Nakano*, Takaki Okatani*, Kosei Otoi*, Hiroshi Une**

* Geospatial Information Authority of Japan, Geographic Information Analysis Research Division - Tsukuba, Japan

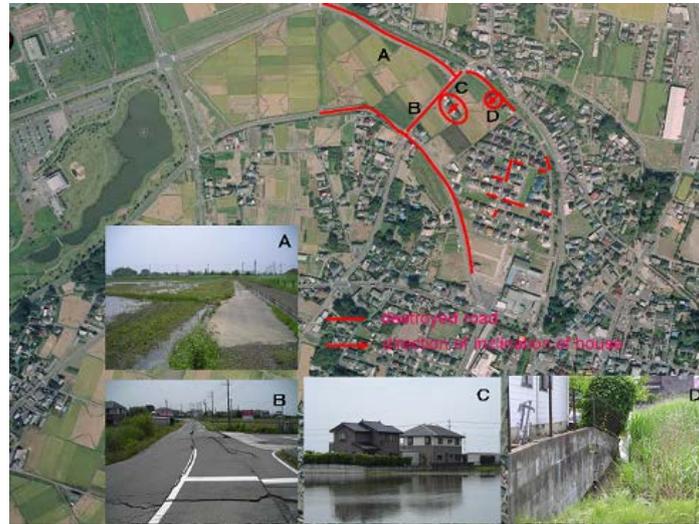
Figure 4. Liquefaction damage in Kinu area, Shimotuma City (Base image is aerial photo taken by GSI in 2008 (CKT2008-2 C3-36).

There is a low lying former river channel in a band across the Kinu area of Shimotsuma City, Ibaraki Prefecture (Fig. 1). This landform is shown on the “Mitsukaido” Land Condition Map published by the GSI. This former river channel sank, and land subsidence and relative ground water level rise are presumed. Service on neighboring roads was suspended as a result of intense cracking and undulation of the road (A in Fig. 4). Liquefaction damage, such as cracking, differential settlement and the tilting of buildings occurred even in the new residential area in the former river channel. The houses were destroyed by the severe subsidence of reclaimed land and the collapse of foundations (B in Fig. 4). The main stream of the Kinu River was shown as meandering in a jinsoku-sokuzu map from about 130 years ago (Fig. 5a). A new river channel was under construction in the olden topographic map (1:50,000 scale) published about 75 years ago (Fig. 5b). In the U.S.Army aerial photo, it is clear that the former river channel turned to be a paddy field about 65 years old(Fig. 5c).
